## BUILDING INVENTORY SHEET

### Specifics

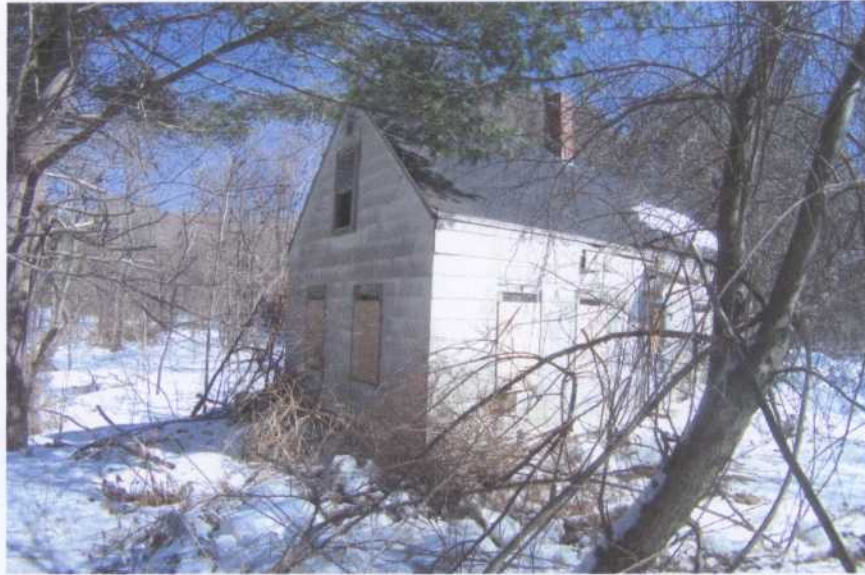
A view of the house from the southwest. Distortion is caused by the use of a wide angle lens.

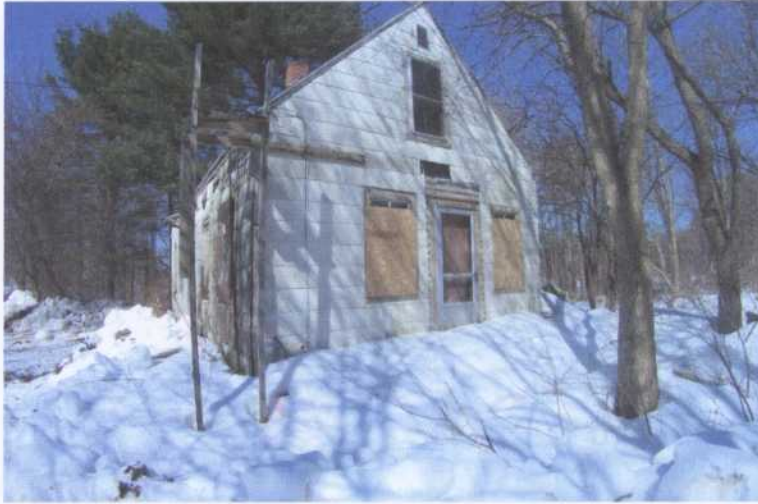
A view of the house from the east showing the door that went into the kitchen.
